UNITED STATES AIR FORCE
AIRCRAFT ACCIDENT INVESTIGATION
BOARD REPORT

KC-135R, T/N 63-8877

DATE OF ACCIDENT: 3 MAY 2013

SUMMARY OF FACTS AND STATEMENT OF OPINION
KC-135R, T/N 63-8877
3 MAY 2013

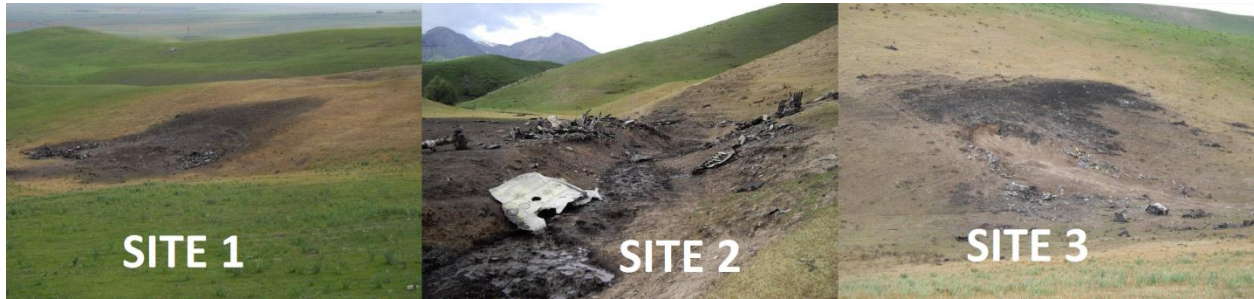
Figure 1. Impact Craters (Tab FF-7 to FF-8, FF-11)

On 3 May 2013, at approximately 1448 hours local time (L), the mishap aircraft (MA), a KC-135R, tail number 63-8877, assigned to the 22d Expeditionary Air Refueling Squadron (22 EARS), 376th Air Expeditionary Wing (376 AEW), Transit Center at Manas, Kyrgyz Republic, crashed approximately 6 miles south of Chaldovar, Kyrgyz Republic (Tabs K-4, Q-5, Q-7). The mishap crew (MC), which consisted of the mishap pilot (MP), the mishap co-pilot (MCP), and the mishap boom operator (MBO), perished during the accident (Tab Q5 to Q-6). Following the loss of its tail section, the MA exploded inflight and further separated into three main sections, impacted the earth, and burned (Tabs J-28 V-24.2, V-25.2). The three impact points were craters in hilly terrain used for grazing livestock (See Figure 1) (Tab FF-5). Approximately 228 cubic meters of soil were contaminated with jet fuel and each crater contained a pattern of burned grass and trees about 35 meters diameter on average (Tab FF-6 to

FF-11, FF-17). The MA was destroyed upon impact, with total loss to government property estimated at \$66.3 million (Tab P-4).
