UNITED STATES AIR FORCE
AIRCRAFT ACCIDENT INVESTIGATION
BOARD REPORT

KC-135R, T/N 63-8877

DATE OF ACCIDENT: 3 MAY 2013

SUMMARY OF FACTS AND STATEMENT OF OPINION
KC-135R, T/N 63-8877
3 MAY 2013

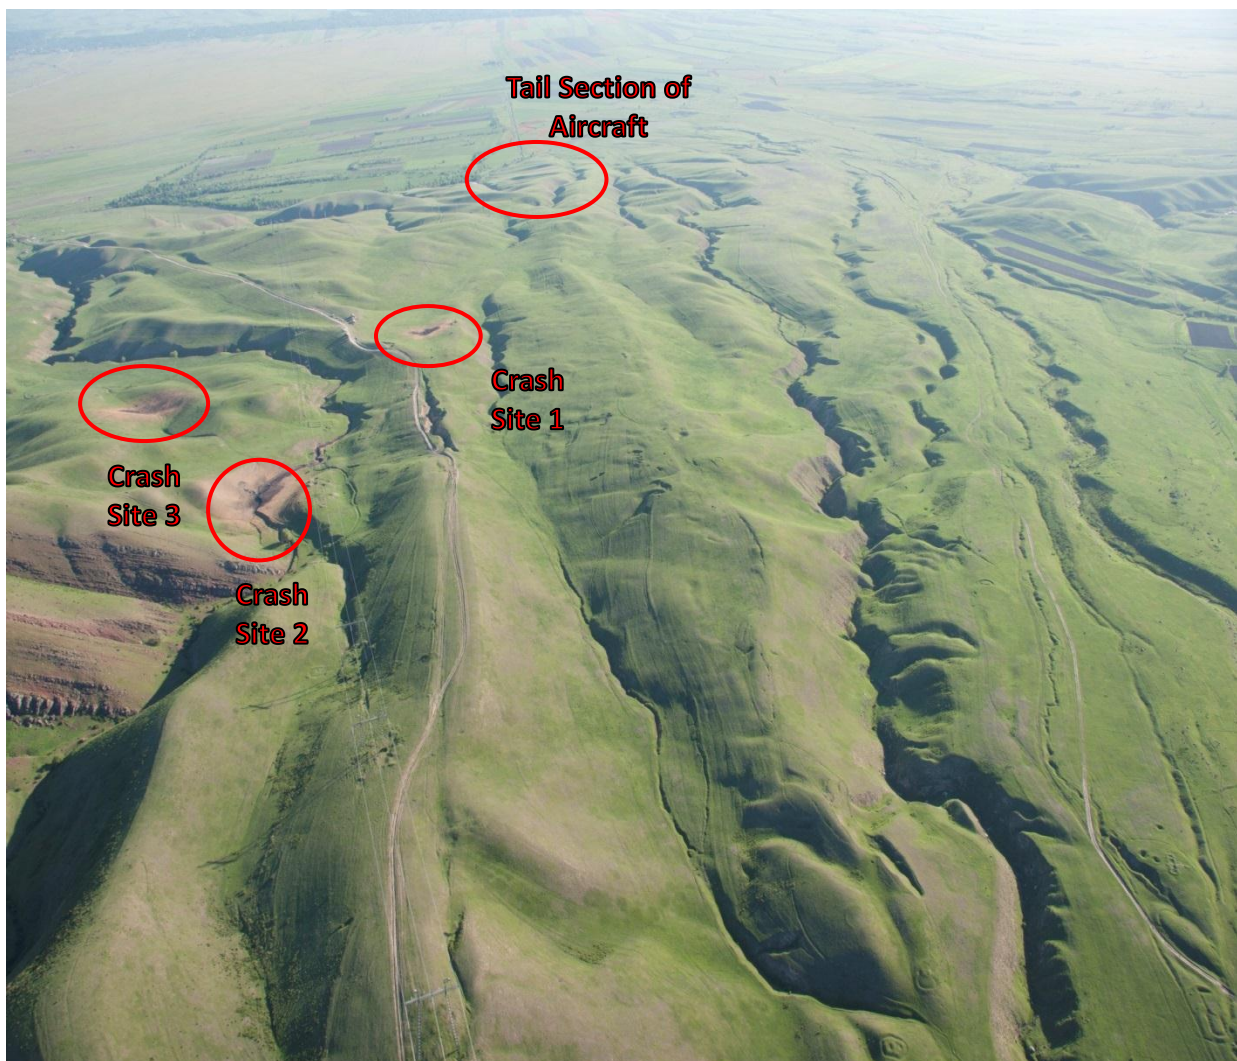
Figure 2. Aerial View of Crash Site (Tab Z-8)

On 3 May 2013, at approximately 1448 hours local time (L), the mishap aircraft (MA), a KC-135R, tail number 63-8877, assigned to the 22d Expeditionary Air Refueling Squadron (22 EARS), 376th Air Expeditionary Wing (376 AEW), Transit Center at Manas, Kyrgyz Republic, crashed approximately 6 miles south of Chaldovar, Kyrgyz Republic (Tabs K-4, Q-5, Q-7). The mishap crew (MC), which consisted of the mishap pilot (MP), the mishap co-pilot (MCP), and the mishap boom operator (MBO), perished during the accident (Tab Q5 to Q-6). Following the loss of its tail section, the MA exploded inflight and further separated into three main sections, impacted the earth, and burned (Tabs J-28 V-24.2, V-25.2). The three impact points were craters in hilly terrain used for grazing livestock (See Figure 1) (Tab FF-5). Approximately 228 cubic meters of soil were contaminated with jet fuel and each crater contained a pattern of burned grass and trees about 35 meters diameter on average (Tab FF-6 to

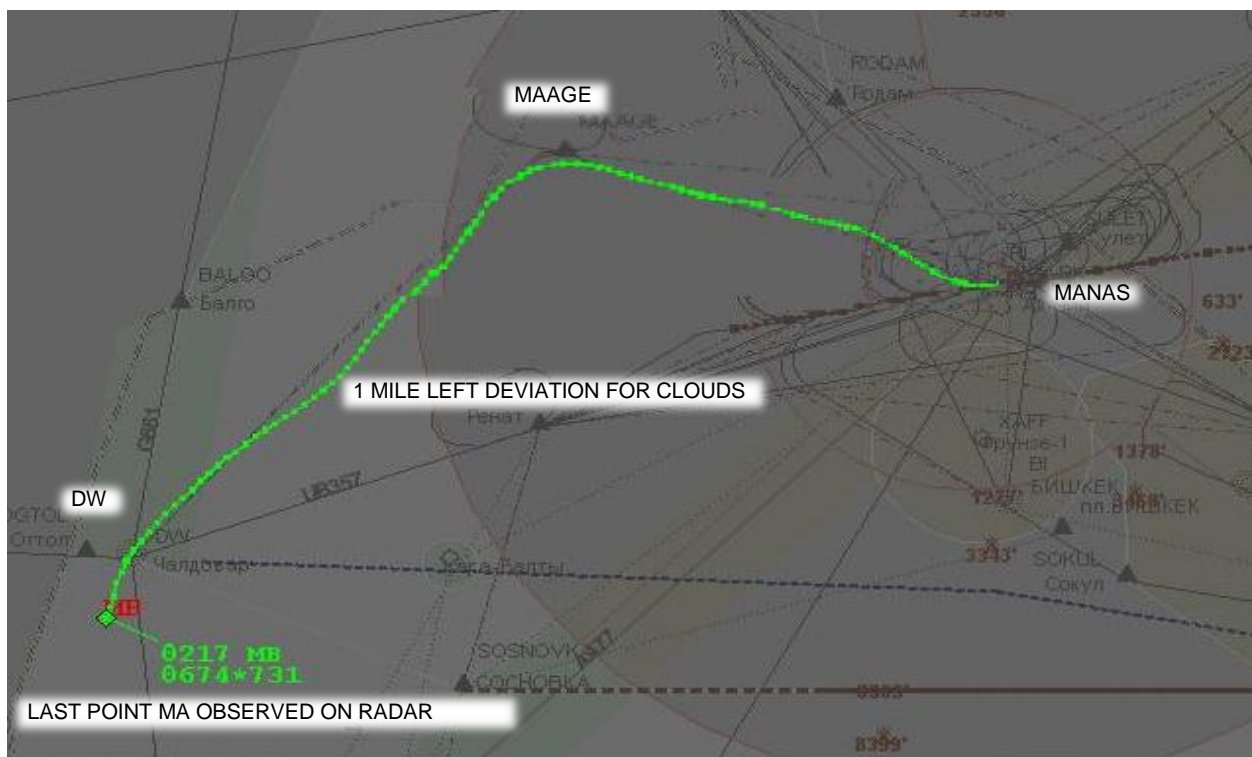
Figure 4. RADAR Plot of MA's Flight Path (Tab Z-3)

(Tab N-4 to N-8). The MC departed at 1437L, 18 minutes prior to the scheduled departure time of 1455L (Tab U-15). Immediately after takeoff, the MP and MCP experienced an unexpected rapid heading change known as a crab in which the MA's nose was pointed at an angle opposite of what would be expected due to the takeoff winds (Tabs N-10, N-13, EE-7, EE-10). The MC did not verbalize any further control difficulties for the next six minutes of flight (Tab N-8 to N-10). However, the nose of the MA hunted left and right about one degree in both directions during the same six minutes (Tab EE-10). The weather RADAR system operated normally for a brief time (about two minutes into the flight) before failing again two minutes later (Tab N-9 to N-10). The MC flew their planned route of flight, except for a one-mile deviation left of course en-route to waypoint DW to avoid cloud buildups (See Figure 4) (Tab N-10 to N-11). The MCP visually identified the building clouds near waypoint DW (Tab N-10 to N-11). At 1446L, the MP reported "clear of the weather" (Tab N-11).

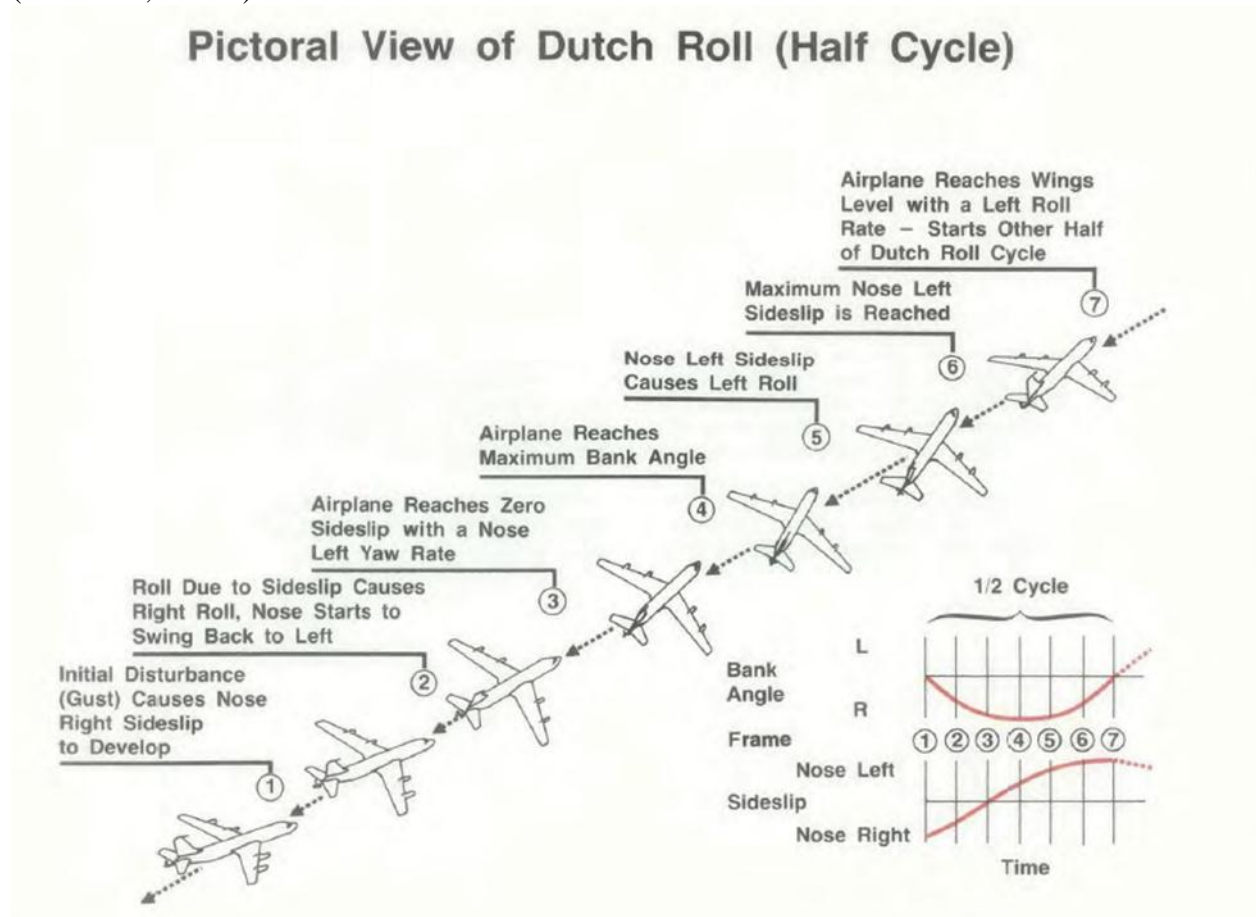
Figure 7. Dutch Roll Illustration (Tab AA-26)

Figure 7 below illustrates how the KC-135 behaves during dutch roll. The yawing of the aircraft's nose is known as sideslip (Tab AA-26). The FDR indirectly measures sideslip as a drift angle (Tab EE-4). Once the sideslip reaches its peak, the roll develops as depicted in red below in Figure 7 (Tab AA-26). Dutch roll damping is reduced as altitude increases (Tab BB-182). As the MA continued to climb, the amplitude of the dutch roll oscillations increased (Tab EE-8, EE-12).

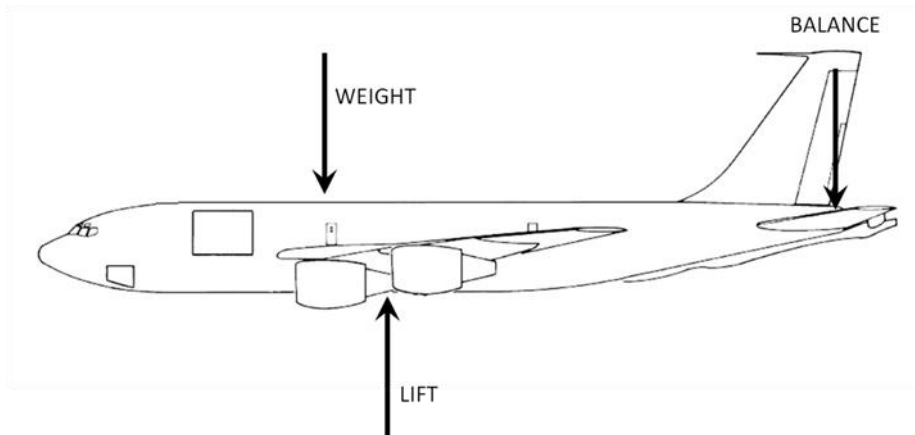
Figure 17. Balancing Stabilizer Load (Tab Z-9).

The structure that failed in Section 48 of the fuselage did so under extreme load. These loads could not be applied unless the vertical stabilizer was firmly attached to the fuselage forward of section 48 prior to the overload (Tab J-29). Following the loss of the stabilizers, the MA would rapidly pitch down. At this point, the MA experienced structural overload beyond design conditions of virtually all components (Tab J-28). This is consistent with the design of conventional swept wing aircraft which dictate a strong nose down pitching moment, normally balanced by the downward force of the horizontal stabilizer (See Figure 17) (Tab J-27 to J-28).

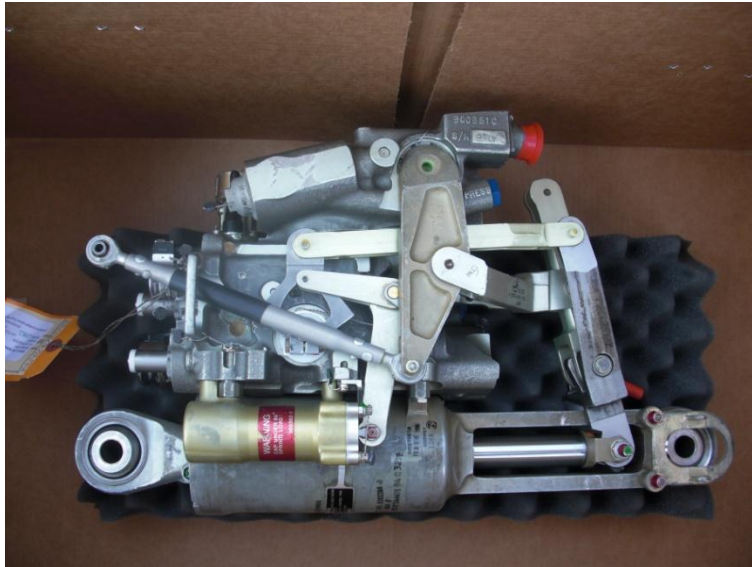
Figure 18. Non-Mishap PCU (Tab Z-10)

The PCU main actuator shaft was broken in the vertical plane after the rudder hinges overloaded and subsequently failed (Tab J-35 to J-36). Failure of PCU linkages also occurred including a broken tablock H-assembly (Tab J-125). The outer fork of the main clevis of the lock lever was bent toward the actuator at the bearing rivet (See Figure 19) (Tab DD-12).
